DETAILS OF INCIDENT	
Date:	09/12/2016
Time:	0950
Location:	Dubbo Provisioning Centre
Rating:	<input checked="" type="checkbox"/> Low <input type="checkbox"/> Moderate <input type="checkbox"/> Serious
Classification: (e.g. WHS, RCI, etc.)	<input checked="" type="checkbox"/> WHS <input type="checkbox"/> RCI <input type="checkbox"/> Other <u>NMIH417</u> If RCI, what is the TCR: _____/20____
Is the incident reportable to Comcare:	<input checked="" type="checkbox"/> No <input type="checkbox"/> Yes, If yes, when was it reported Click here to enter a date.
DESCRIPTION OF INCIDENT (who, what, how, when)	
<p>During the use of a new spitfire pressure cleaner the power point that it was running off shorted out and burnt the 15amp power point and plug. Upon further investigation it was mentioned by one of the ARTC staff that the power point was becoming loose when plugging in appliances.</p> <p>It was suggested by ARTC electrical staff that this may have caused a hot spot in the power point which created a short circuit resulting in the incident.</p>

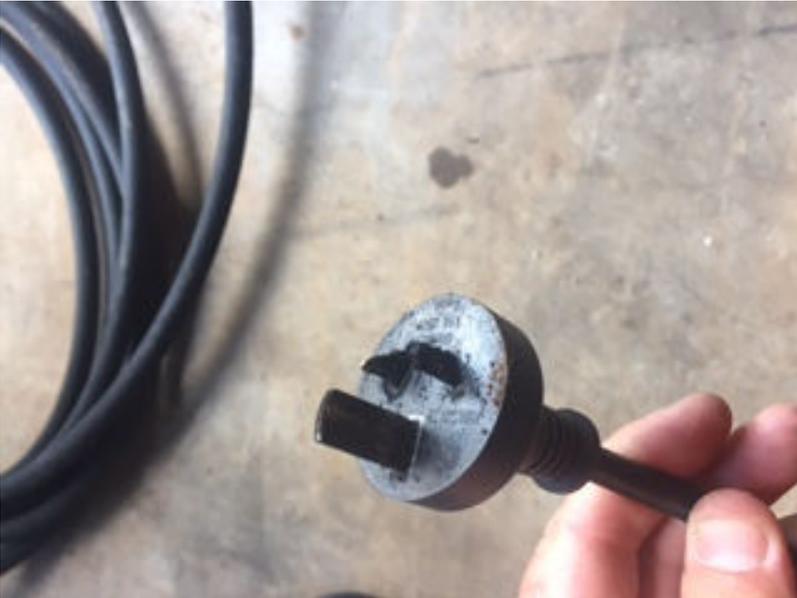
DETAILS OF INJURY/ILLNESS/IMPACT/DAMAGE (include photographs and (if possible) an estimate for when track can be released)	
<p>Burnt plug on pressure cleaner</p>

ARTC electricians isolated the power supply and then replaced power point with new and replaced burnt plug on pressure washer.
 Power point and pressure washer both tested for faults resulting in nil faults found.
 Power points throughout yard will be checked by ARTC electrical staff.

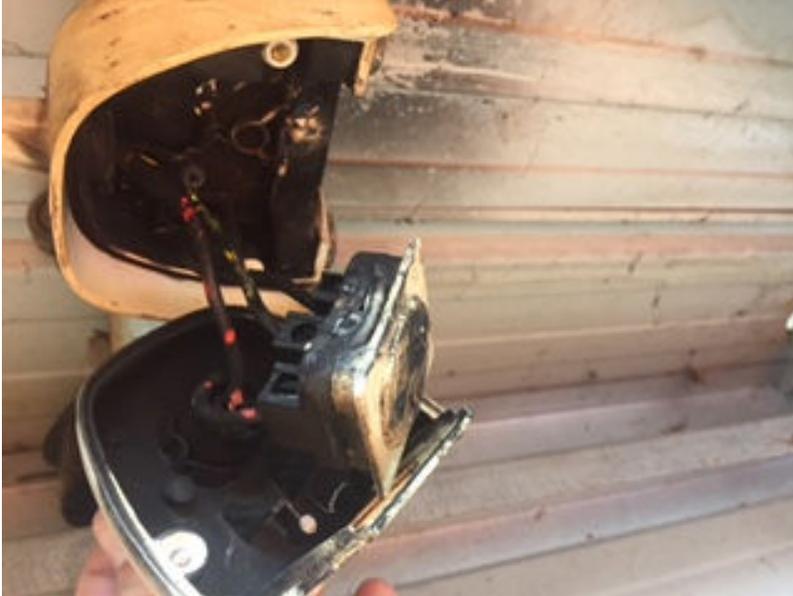
Burnt out power point –

Name	Simon Benson
Position	Work Group Leader
Shared Learning's	It is suggested that other provisioning centres inspect the condition of all power points prior to use.
