DETAILS OF INCIDENT	
Date:	12/02/2017
Time:	17:49
Location:	Moree
Rating:	<input checked="" type="checkbox"/> Moderate <input type="checkbox"/> Serious
Classification: (e.g. WHS, RCI, etc.)	<input type="checkbox"/> WHS <input checked="" type="checkbox"/> RCI <input type="checkbox"/> Other _____ If RCI, what is the TCR: 1770/2017
Is the incident reportable to Comcare:	<input checked="" type="checkbox"/> No <input type="checkbox"/> Yes, If yes, when was it reported Click here to enter a date.
DESCRIPTION OF INCIDENT (who, what, how, when)	
<p>On Sunday 12/2/17 the Narrabri Team Leader observed a kink in the track over Pier 4 of the structure at 667.370km Moree. On further investigation it was found that the pier had rotated due to the extreme temperatures in the area and subsequent ground shrinkage. As a consequence the Moree to Camurra section of the Werris Creek to Mungindi Line was closed.</p>	
DETAILS OF INJURY/ILLNESS/IMPACT/DAMAGE (include photographs and, if possible, an estimate for when the track can be released)

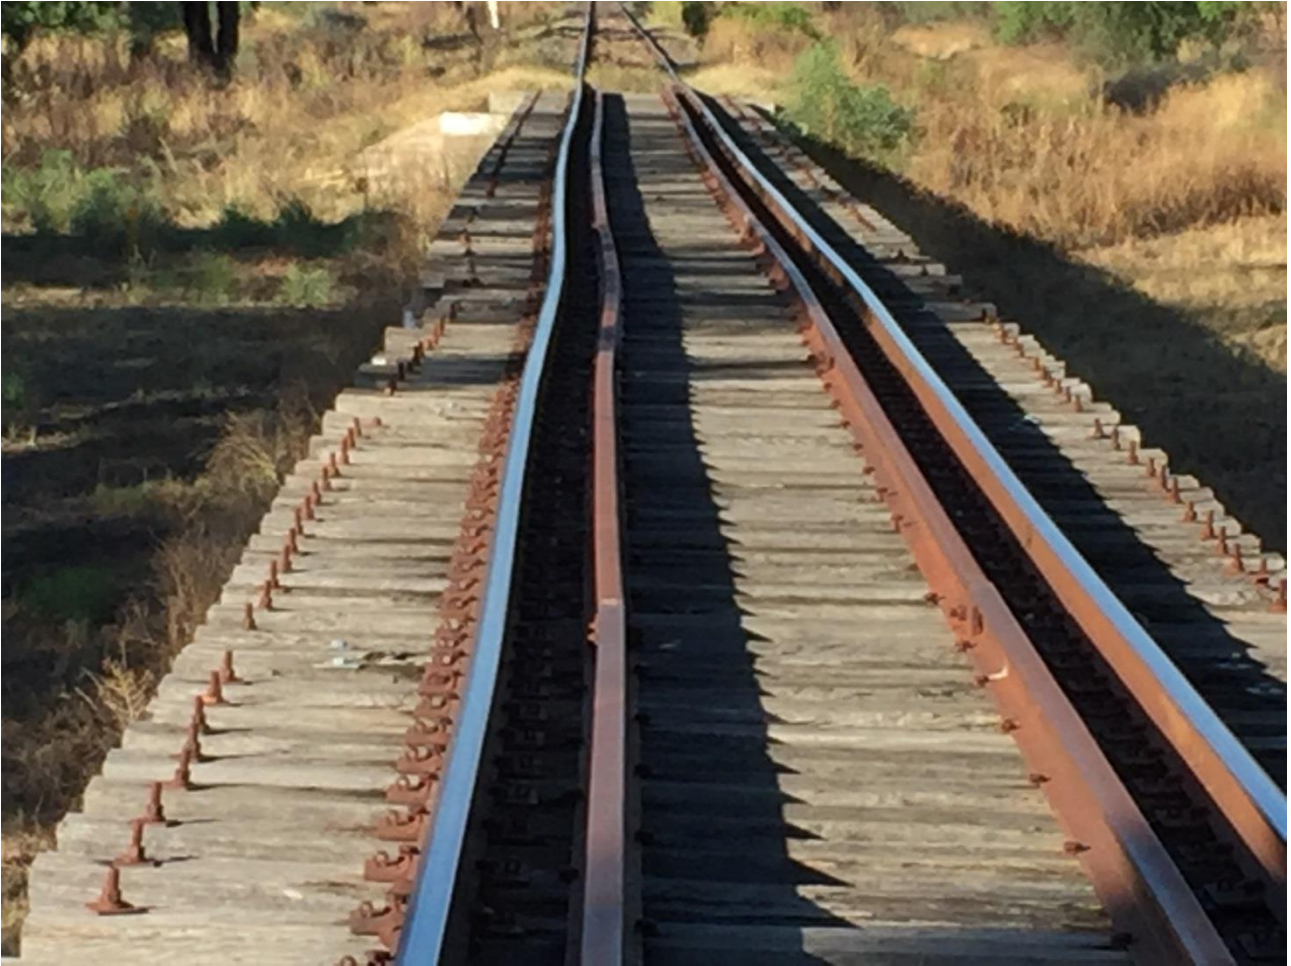
<p>No injury however bridge closed and subsequent section of track.</p>	
IMMEDIATE ACTIONS/CONTROLS TAKEN FOLLOWING INCIDENT TO PREVENT A REPEAT INCIDENT UNTIL INVESTIGATION IS COMPLETE	
<p>Track closed until further notice, operators notified to ascertain train running and repairs planned.</p>	
AUTHORISED BY	
Name	Shane Pratten
Position	Area Manager Structures
Shared Learnings	It is important to remain vigilant in our inspections of track to identify defects especially in times of extreme weather conditions.
