DETAILS OF INCIDENT	
Date:	22/02/2017
Time:	0955hrs
Location:	Milguy 707.262km
Rating:	<input type="checkbox"/> Low <input checked="" type="checkbox"/> Moderate <input type="checkbox"/> Serious
Classification: (e.g. WHS, RCI, etc.)	<input checked="" type="checkbox"/> WHS <input type="checkbox"/> RCI <input type="checkbox"/> Other <u>9000882</u> If RCI, what is the TCR: _____/20____
Is the incident reportable to Comcare:	<input checked="" type="checkbox"/> No <input type="checkbox"/> Yes, If yes, when was it reported Click here to enter a date.
DESCRIPTION OF INCIDENT (who, what, how, when)	
<p>At 0955hrs on the 22nd of February, an ARTC worker received lacerations to their right ring finger while loading equipment onto a vehicle whilst on track.</p> <p>The equipment was loaded by way of by two person lift when the incident occurred.</p> <p>Worker received injury when his finger became caught between the equipment being loaded and a sharp edge of the vehicles aluminium tray.</p> <p>Incident hotline contacted and manager informed.</p> <p><i>(Please note if people listed here are ARTC employees or contractors)</i></p>

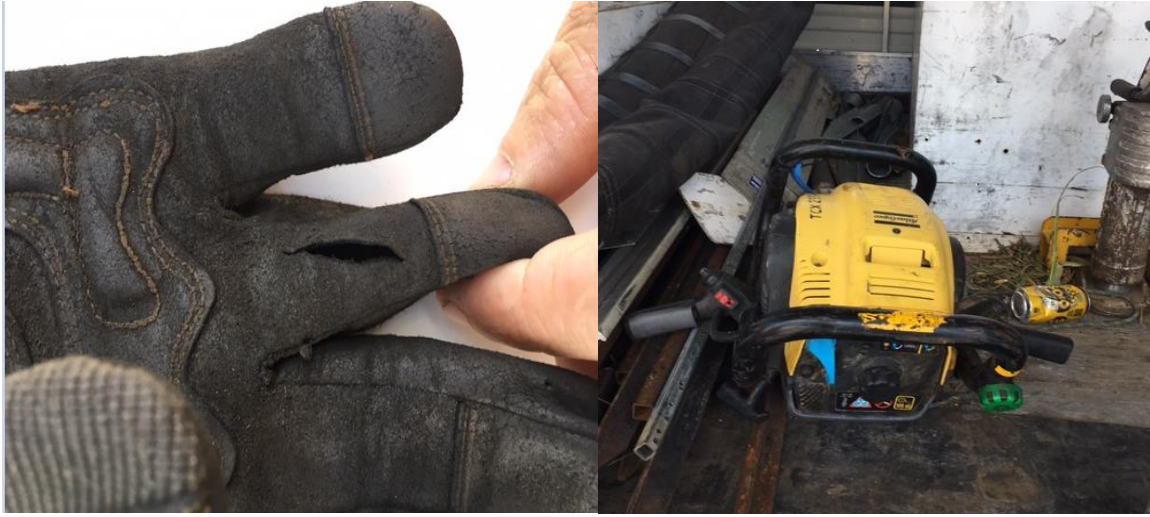
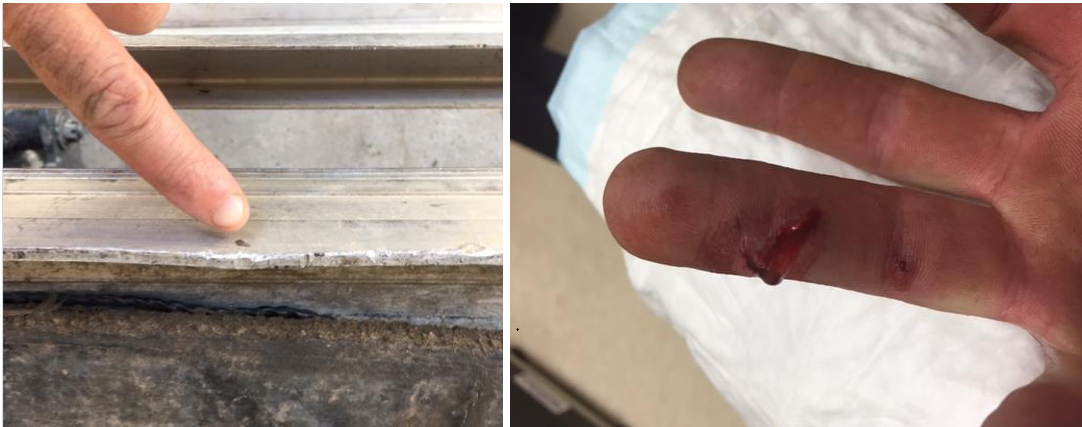
DETAILS OF INJURY/ILLNESS/IMPACT/DAMAGE (include photographs and (if possible) an estimate for when track can be released)

Name	Shannon Hobbs
Position	Work Group Leader
Shared Learning's	Risk assess any tools and equipment that are to be lifted manually, risk assess height. Inspect vehicle bodies for damage and sharp edges/ surfaces. If any sharp edges are discovered they are to be rectified prior to use. Incident to be discussed at the VMC Risk assess any other equipment that is required to be manually lifted on to vehicles whilst on track that has the potential to cause similar or more serious injuries. Investigate mechanical lifting devices that can be fitted and utilised to eliminate risk
