SAFETY ALERT

Synthetic fibre sling fails

Safety Alert No: SA17-04 File number: PUB17/208 SinNot: 2017/00593 Phone: 1300 814 609 Date published: 10 May 2017

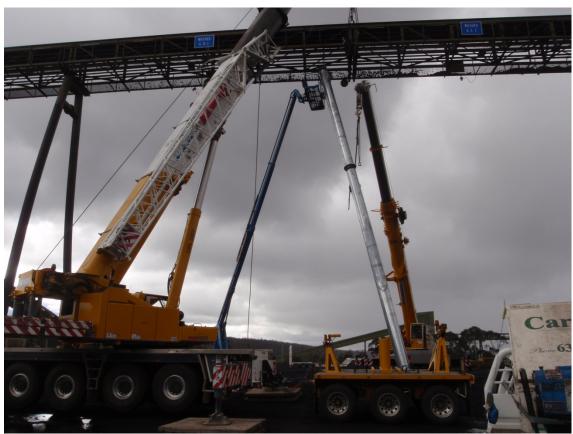
A crane was lifting a leg assembly into position on a skyline conveyor. One of the synthetic fibre slings that were attached to the leg assembly failed. This allowed the leg assembly to move and come into contact with a boom-type elevated work platform (EWP).

Figure 1: Leg assembly resting on elevated work platform

When lifting any load using synthetic or soft slings, ensure that:

- there is no potential for the sling to be damaged during the lift, such as by sharp edges, squashing or other methods*
- slings are inspected by a competent person for damage before each lift
- where possible, loads should be lifted with designated lift points. This should be considered during the fabrication of equipment.
- riggers and doggers who sling the load are competent and licensed for the lift
- where the load has sharp edges or components are attached to it (for example, cleats), chain or wire rope slings are used. Synthetic slings must not be used unless they are protected from these sharp edges.
- lift plans for crane operations contain information, including working load limit, for all items to be used for the lift
- sling selection considers the potential for damage to the sling from the load
- all 'drop' or 'fall' zones are clear and secured.

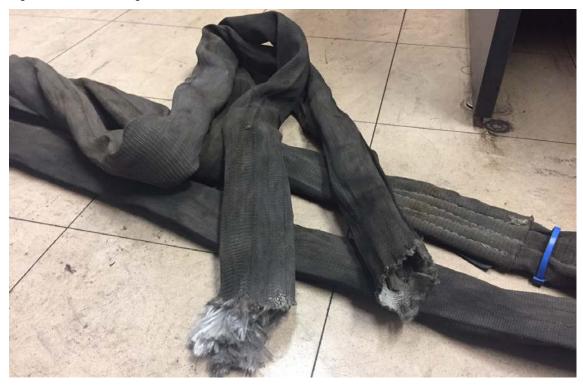
It appears that the slings had worn on the sharp edges of the flange and the bolts. The remaining sling, when removed, also had some cuts and abrasions through the outer casing and into the core.
