DETAILS OF INCIDENT	
Date:	30/10/2016
Time:	11:10 AM
Location:	Scholey Street
Rating:	<input type="checkbox"/> Moderate <input checked="" type="checkbox"/> Serious
Classification: (e.g. WHS, RCI, etc.)	<input checked="" type="checkbox"/> WHS <input type="checkbox"/> RCI <input type="checkbox"/> Other _____ If RCI, what is the TCR: _____/20____
Is the incident reportable to Comcare:	<input checked="" type="checkbox"/> No <input type="checkbox"/> Yes, If yes, when was it reported Click here to enter a date.
DESCRIPTION OF INCIDENT (who, what, how, when)	
<p>October Mains Closedown - Job #15 - Scholey St - 96pts crossing replacement.</p> <p>A contract welder was attempting to repair a hand held rail profiler when the steel strap contained inside the housing cover unravelled, sprung free and contacted (wrapped around) the workers uncovered hands causing serious cuts to both left and right hands.</p> <p>The worker had taken the housing cover off the fly wheel, and had wound the pull cord manually on the fly wheel before starting the machine. The worker then attempted to replace the cover whilst the grinder was still operational. The fly wheel then came in contact with the steel strap in

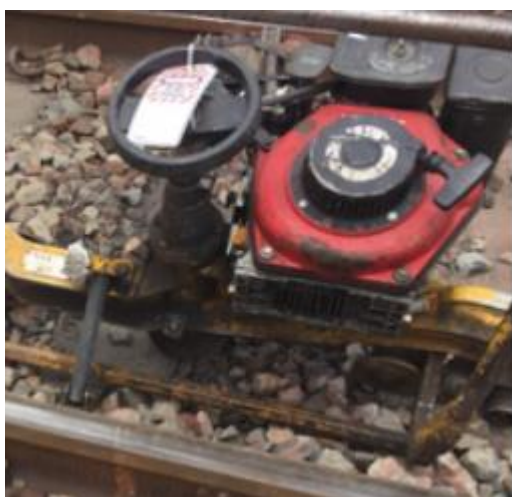
Separate unit shown below with pull cord and cover in place.
