LESSONS LEARNT

DETAILS	Report Reference Number	5029/2018	
Event Type	<input type="checkbox"/> Hazard	<input type="checkbox"/> Near Miss	<input checked="" type="checkbox"/> Incident
Relates To	<input type="checkbox"/> WHS	<input type="checkbox"/> Environment	<input checked="" type="checkbox"/> Rail Safety
Date	25/05/2018	Business Unit	Hunter Valley
Detailed Description of Event (include relevant images)			
<p>On Friday 25th May, Protection Officer (PO) requested a Track Occupancy Authority (TOA) from the Network Controller (NC) to complete transformer replacement on the Mt Thorley Branch Line.</p> <p>The PO advised the NC 201/203 points would be clipped and locked under Look Out Working (LOW), and TOA 19 was granted. Later the NC contacted the PO to identify if the points were being locked. The PO confirmed they had been locked, although there was no protection arrangements in place to undertake the task of attaching the point clips.</p>

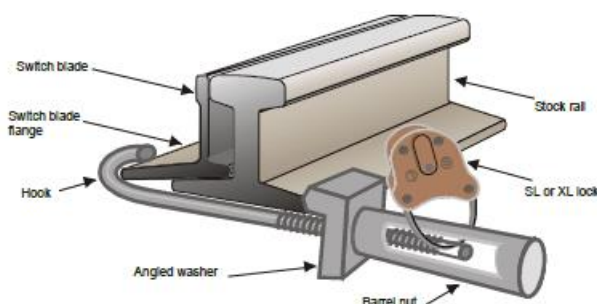
<p>Figure 1 Points clipped and locked</p>

Team members have gained access to live unprotected track in order to clip and lock the set of points, as the points were located outside of the TOA limits.

- Whenever access to track is required in order to clip and lock points, an appropriate work on track method/authority must be in place.
- When clipping and locking points that are located outside the requested worksite protection limits, an appropriate work on track method/authority must be in place to prevent rail traffic approaching
- If lookout working is assessed as appropriate for the task, a lookout must be in place to identify approaching rail traffic, while the qualified person clips and locks the points

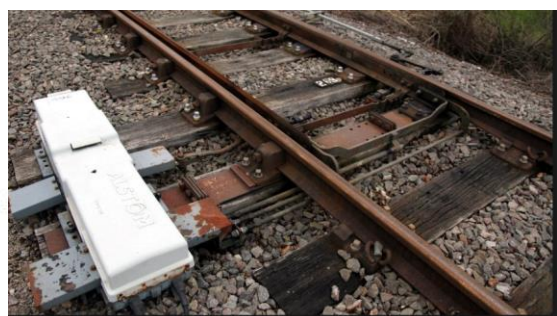
<p>Figure 2 Set of points</p>
