ARTC No. B0005

Changes to Piggybacking Process

Type: Safety Information

AUSTRALIAN RAIL TRACK CORPORATION

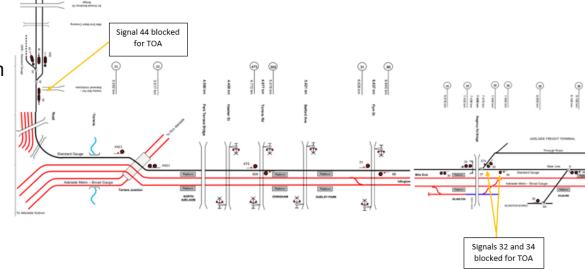
- Protection Officer (PO) (contractor) obtained a TOA from Network Control (NC) with the limits being from signals 32 & 34 at Islington South to signal 44 at Mile End.

- ARTC Track Inspector arrived at signal 34 Islington to continue the patrol and requested permission from the PO (TOA #1) to travel within the limits of TOA #1 from signal 34 Islington to signal 44 Mile End.

- At 07:42 hrs, NC requested the PO to hand back TOA #1, to facilitate a Locomotive and coach movement out of the South End of Islington, and the PO handed back the TOA at 7.44hrs, failing to communicate this with the ARTC Track Inspector leaving him on track without protection.

- At 07:46 hrs, Track Inspector reported to the NC on arrival at signal 44 Mile End to obtain permission to continue.
- At this point the NC realised TOA #1 had been handed back with the Track Supervisor still on track and immediately placed blocking protection to prevent any train movements from entering the section of track occupied by the Track Inspector.
