**TITLE/SUBJECT:**

Inland Rail: N2NS SP1 – Trailer Detachment

Inland Rail Narrabri to North Star – SP1 (N2NS – SP1), Edgeroi NSW

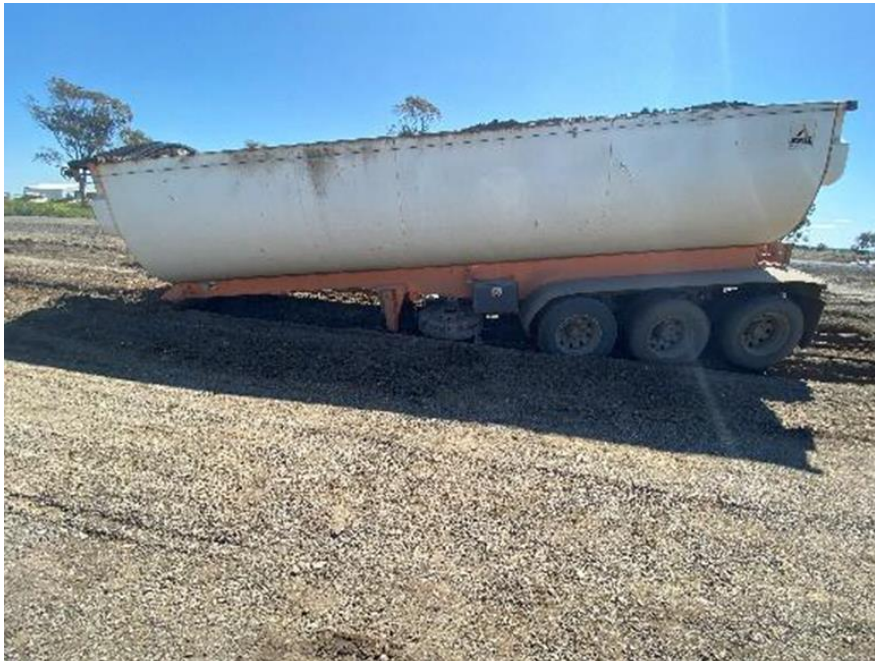
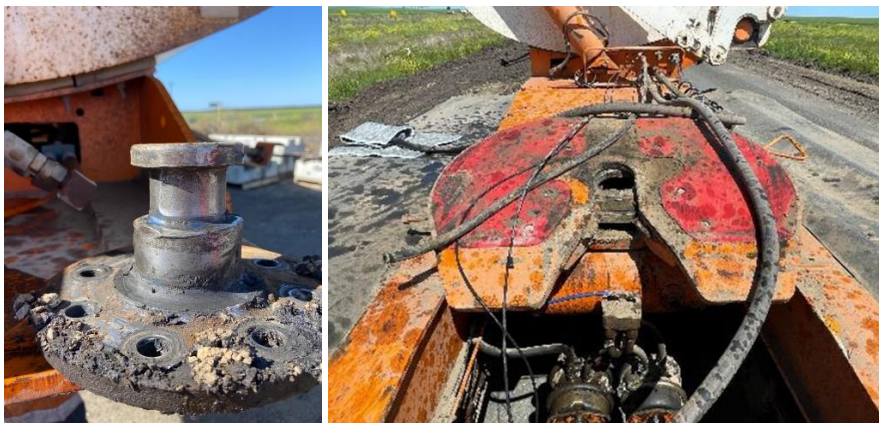
As the driver entered the alignment, the rear trailer of the triple combination detached from the middle rear trailer in front.

It came to rest on its connection housing, adjacent to the main alignment

- King pin was assessed as being in poor condition with significant wear.
- A replacement king pin was fitted to the rear trailer and after the inspection the fitter deemed the trailer fit for safe operation.

1. ARTC and Inland Rail operations are advised to conduct verification and maintenance checks on all trailer combinations with a focus on the king pin and turntable locking mechanism condition, confirming they have been maintained in accordance with the manufacturers specification and fit for operation.
2. Share this HSE Flash Alert with your team to ensure that the contents are discussed/explained to your staff.
3. If working with Contractors, ensure they are made aware of this HSE Flash Alert.
4. Ensure a method of sign-off is obtained (e.g. via toolbox/safety meetings/morning pre-start/briefings, etc;) to verify that the HSE Flash Alert has been distributed and discussed.
5. If you have any safety concerns with this HSE Flash Alert, please speak directly to your supervisor.
