# VALUES SHARE | 5446 SPAD SIGNAL HJ36

# VALUES SHARE | 5446 PROCEED AUTHORITY EXCEEDED

# VALUES SHARE | NEAR MISS AT BROADFORD PEDESTRIAN CROSSING

# VALUES SHARE | TANYINNA LEVEL CROSSING ACCIDENT 11/07/2025

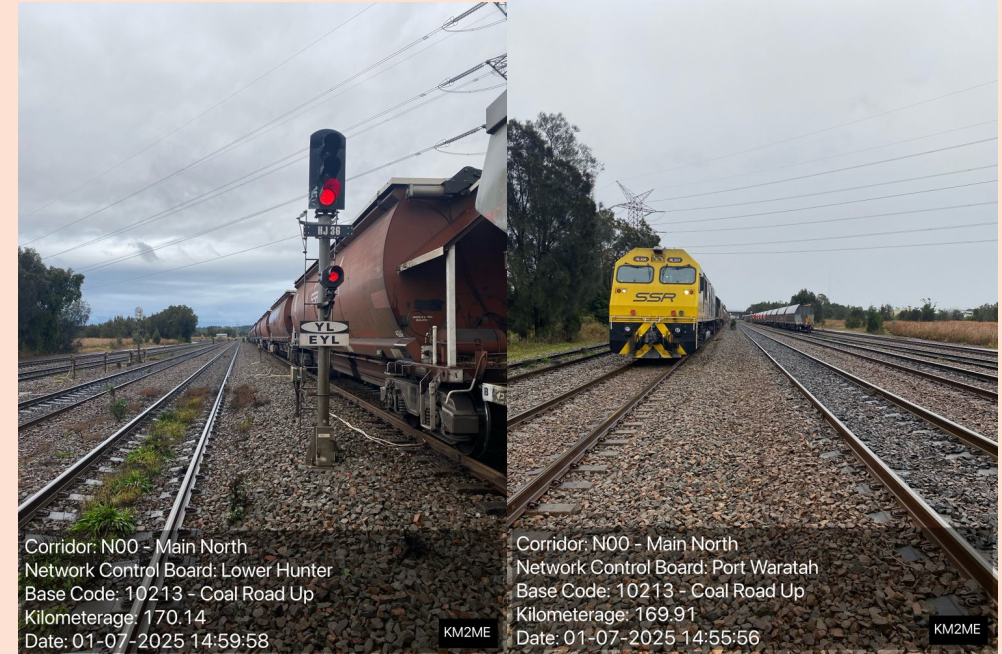
- At 1320 hours train 5446 passed signal HJ36 Sandgate on the up-coal line without authority. The signal was passed by 100 meters with a speed of 32km/h – No emergency brakes were applied.
- Train 5446 called Network Control to advise that they had passed the signal at stop.
- Signal HJ36 was booked out at the time and trains were being talked past this signal at stop with alternate working due to track circuit failures with Sandgate flooding due to extreme weather.
- The Network Controller at the time had previously authorised multiple trains passed the signal at stop due to the alternate working and had acknowledged the SPAD alarm, however did not immediately make an emergency call.
- There were no conflicting or opposing movements, the line is a unidirectional.

- Driver advised to cease all train movements and contact Supervisor
- TTM advised, MNO Advised
- Rail Operator advised – arranging Drug & Alcohol testing.

Train crews to remain vigilant when observing signal indications.  
Network controllers to be alert and attentive to all SPAD alarms.

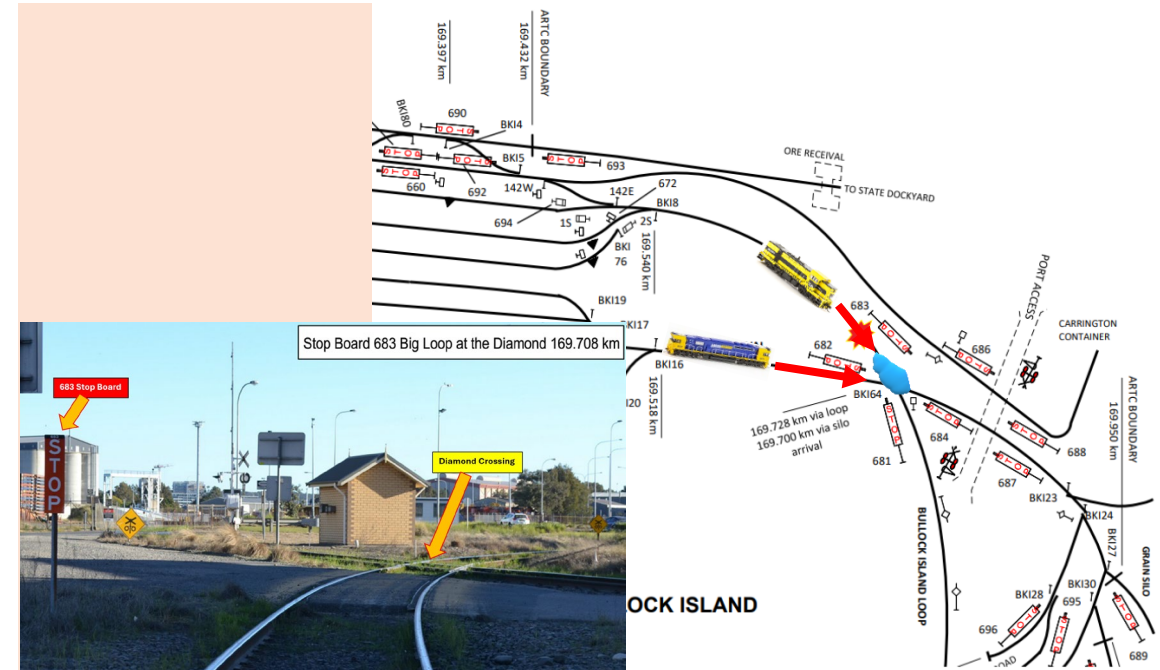
- 1910 hours driver of 5446 contacted the Terminal Coordinator seeking permission to travel through the Diamond on the Big Loop however there was water over the track in the Diamond as reported by the driver.
- Terminal Coordinator advised that they would need to undertake their own assessment to travel to the Diamond, however they would be required to contact the Terminal Coordinator when they arrived at the Diamond
- 5446 **did not** have the permission of the Terminal Coordinator to pass 683 Stop Board which is situated before the Diamond.
- 1949 hours – driver of 5446 contacted Terminal Coordinator. As the Terminal Coordinator answered the call, they observed 5446 travelling through the Diamond via the local CCTV cameras having passed 683 Stop Board

- Driver advised to cease all train movements and contact supervisor
- TTM advised
- Train crew to be relieved with D/A testing to be conducted
- Investigation commenced

- Train crews to remain vigilant when observing signal indications and stop boards.

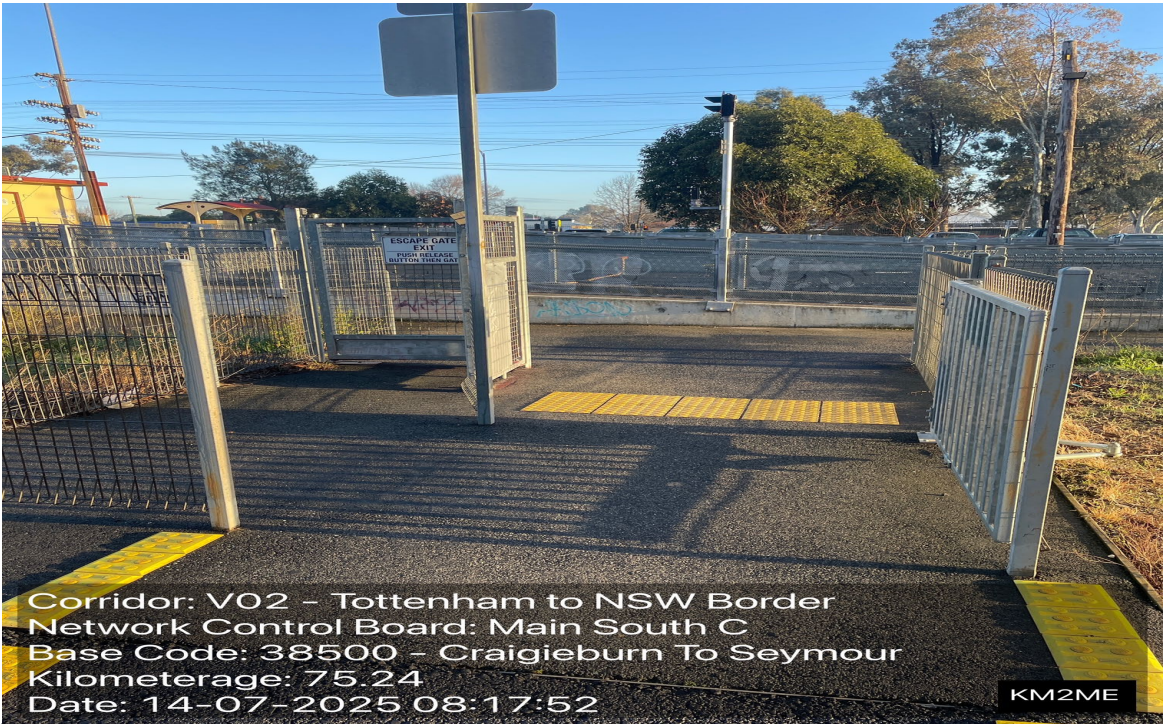
- 4BM9 reported a near miss, possible pedestrian strike at Broadford pedestrian crossing 75.251km. Crew applied emergency application and brought train to a stand approximately 1000 meters passed the crossing.
- A person in a mobility scooter was crossing the track and a train approached causing the gates to close. The person made their way into the emergency exit refuge requiring assistance from another member of the public to exit.

- Centrol notified. To bring trains to a stand until notified. Emergency services notified.
- Emergency services reported female pedestrian OK.
- Signal electrician and Civil tested and certified the pedestrian crossing.

- *Ensure correct maintenance is performed and always ensure crossing operating correctly.*

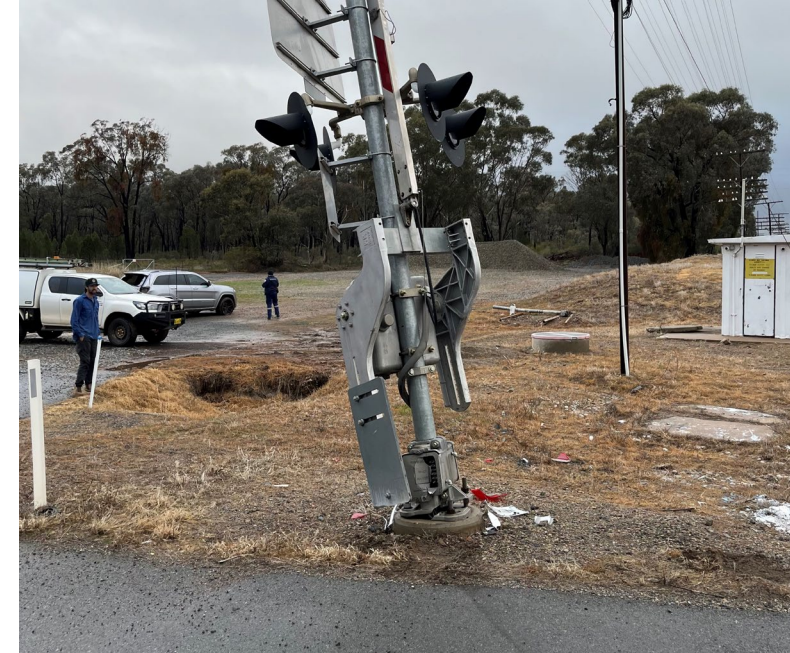
- Member of public was travelling North toward Cootamundra from Junee when they lost control at Tanyinna level crossing impacting with the boom stand.
- Localised severe fog and black ice on the road.
- Vehicle sustained damage to rear of vehicle.
- No injuries to driver.

- Protected site through CAN conditions.
- Area Manager advised.
- Staff engaged traffic control to protect the level crossing and staff during temporary repair.
- Work with local road authority will continue to improve conditions.

- Work with local road authority to improve road conditions to reduce the risk of further repeat incidents at this location.

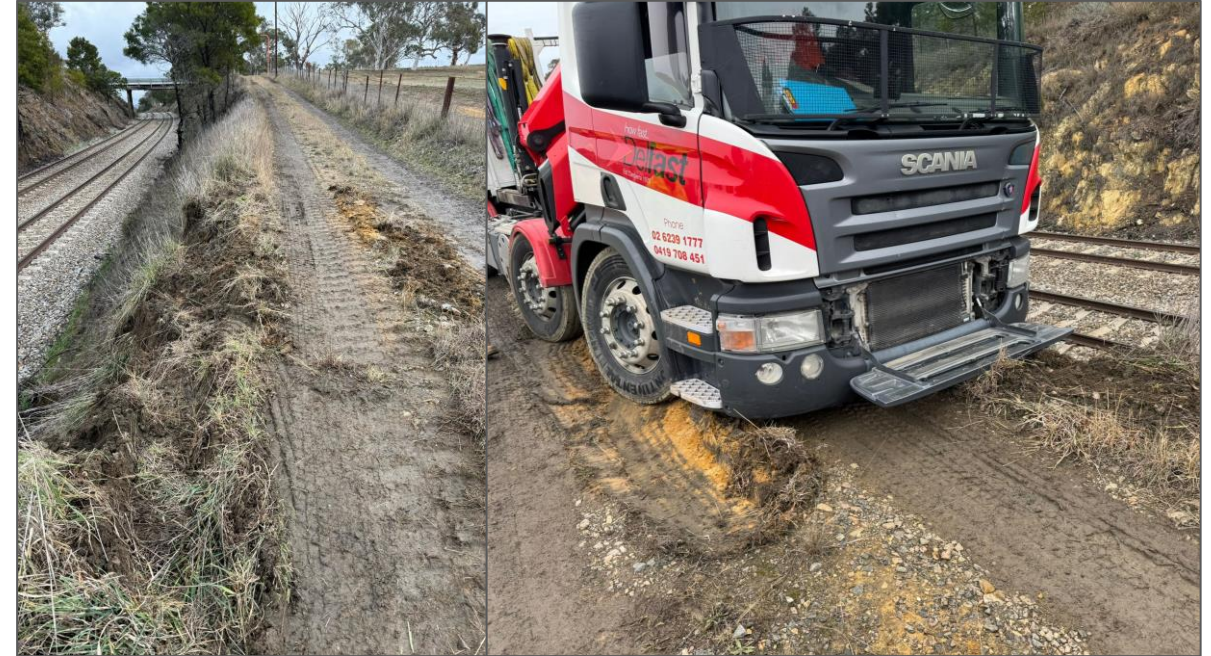
- As part of project establishment, a large tilt-tray truck had delivered a portable lunchroom to the site compound.
- When exiting the site along the same up-side access road, the truck veered slightly to avoid an aerial line wire pole. The truck lost traction and began to slide toward the edge of the access road which was atop a cutting.
- The driver stopped and contacted the site supervisor.
- Whilst working to secure the vehicle, an XPT passenger service passed by on the Down track.

- Driver contacted Site Supervisor.
- Truck secured in place to prevent further sliding.
- Safe recovery of the truck planned and executed.
- Area Manager and Project Manager advised.
- Project review of access roads, including site compound selection

- Understand heavy/wide load vehicle types required for the work and assess access roads to identify and control risks or adjust plans to suit.
