SAFETY ALERT

Potential Class 1 - Backhoe Tipover

Bayswater Level Crossing Removal Project (Melbourne)

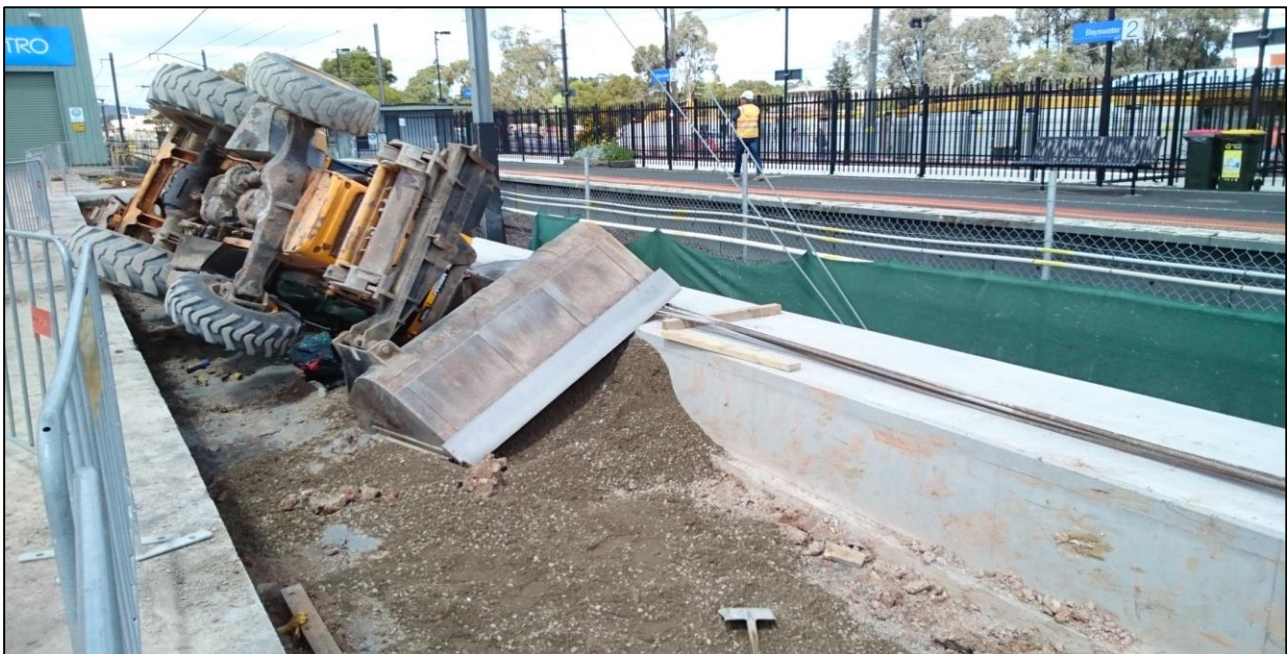
On the 13th of October 2016 a backhoe was backfilling a common services trench. Whilst emptying and spreading a bucket of crushed rock into the trench the front left wheel slipped into the shallow trench, with the machine subsequently losing stability and tipping onto its left side within the trench. The operator was able to get out from the cabin uninjured. A worker within the trench area (not in immediate vicinity) also exited the area uninjured.

Investigations are ongoing and the following priority actions are taking place to ensure mobile plant critical controls are being effectively implemented:

- Review of project plant selection and use processes and criteria.
- Review of task SWMS and methodology in relation to the identification and use of suitable plant for civil works involving excavation, trenching and backfilling
- Review of controls in relation to physical protection in and around excavations and trenches
