DETAILS OF INCIDENT	
Date:	29/11/2016
Time:	1030
Location:	Breeza
Rating:	<input checked="" type="checkbox"/> Moderate <input type="checkbox"/> Serious
Classification: (e.g. WHS, RCI, etc.)	<input type="checkbox"/> WHS <input checked="" type="checkbox"/> RCI <input type="checkbox"/> Other _____ If RCI, what is the TCR: _____/20____
Is the incident reportable to Comcare:	<input checked="" type="checkbox"/> No <input type="checkbox"/> Yes, If yes, when was it reported <a href="#">Click here to enter a date.</a>
DESCRIPTION OF INCIDENT (who, what, how, when)	
<p>ARTC Maintenance Team was working under Track Occupancy Authority's (TOA) to correct track geometry defects. Between TOA's, maintenance team moved plant and personnel outside danger zone however left hand tools (two jacks and one cross level board) on the ballast shoulder. Workers thought that all tools were in a safe place. The first train to come through the section after the work site handed the track back has struck the edge of a cross level board, causing the handle to dislodge from the main section.</p> <p><i>(Please note if people listed here are ARTC employees or contractors)</i></p>

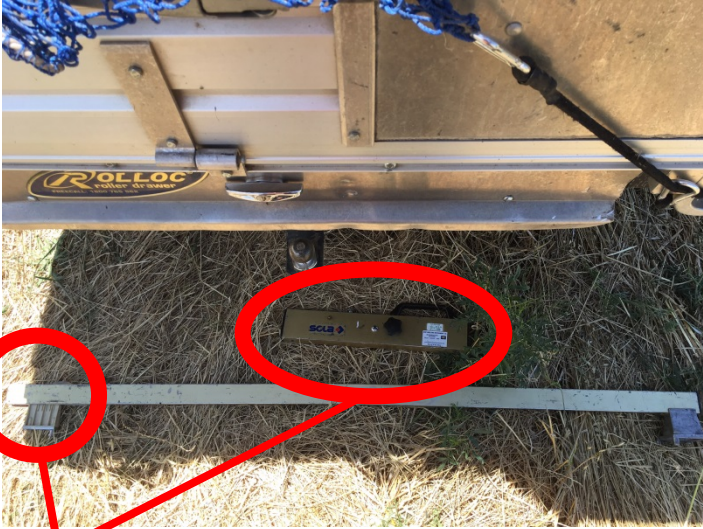
DETAILS OF INJURY/ILLNESS/IMPACT/DAMAGE (include photographs and, if possible, an estimate for when the track can be released)	
<p>Image 1: Handle broken away from cross level board.</p> <p>Image 2: Tools stored on ballast shoulder (archived image from another work site).</p> <p>Image 3: Approximate location of cross level board when struck by train.</p>

<p>Handle is supposed to be connected to the cross level board at the circle end. Handle was connected by one screw.</p>

Work site stopped, incident discussed.

All tools, equipment & materials to be kept out of the danger zone under live run conditions.

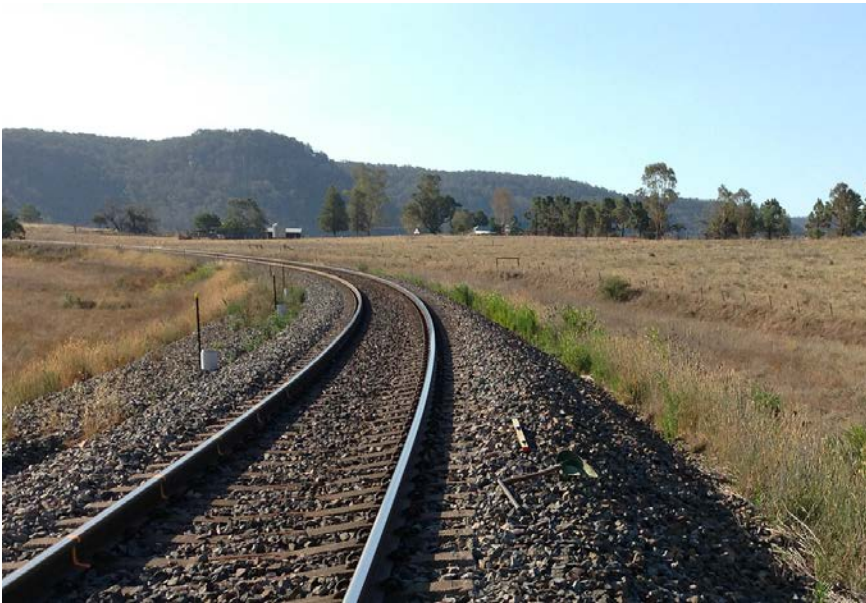
Image 2: Archived image (from a different work site) showing common practice of storing tools on ballast shoulder.

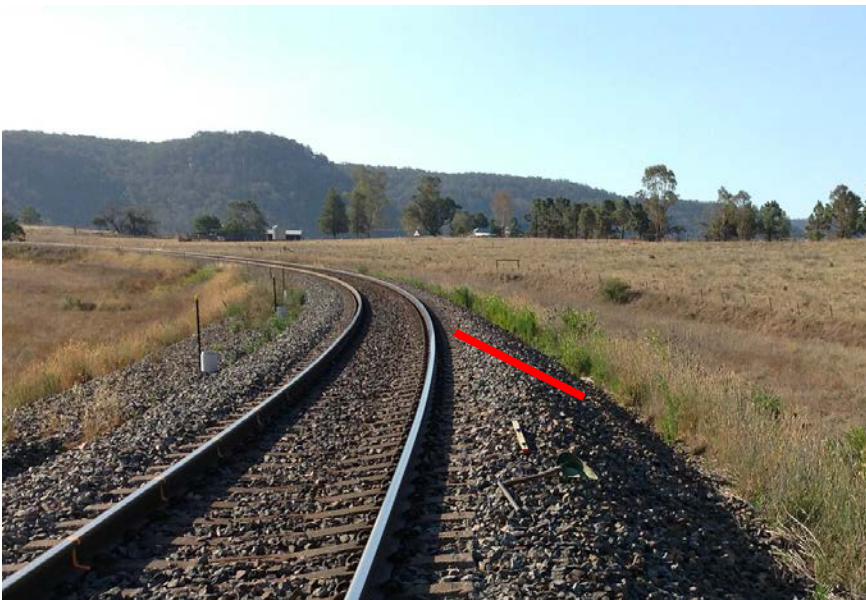
Image 3: Red line indicates cross level board being stored on ballast shoulder. The left hand edge was struck by the train.

<b>Name</b>	Nick Brown
<b>Position</b>	Area Manager Gunnedah
<b>Shared Learnings</b>	<i>Protection Officer must confirm all personnel and equipment clear of Danger Zone prior to handing work site back to Network Controller to eliminate risk of collision.</i>
