Downer Zero Harm Bulletin - Live Strand Wire

Live Network during an Aerial Installation

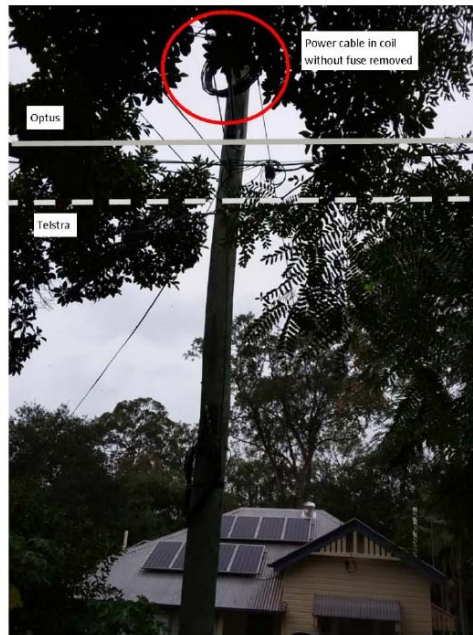
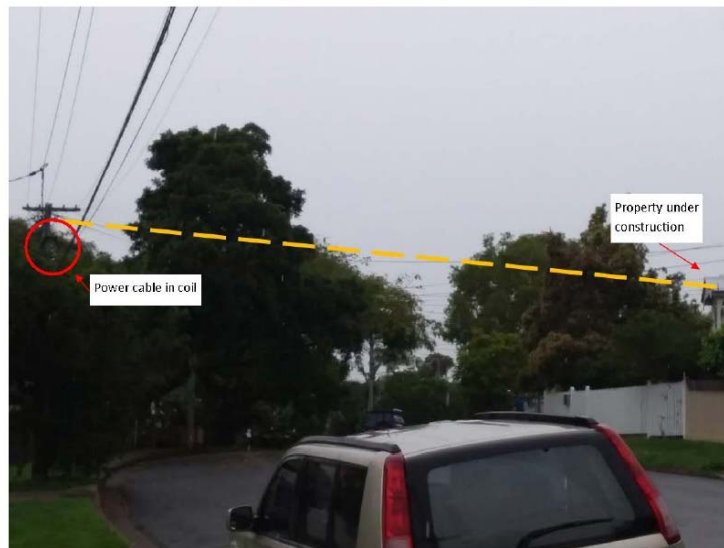
Figure 1 and 2. Power cable removed from dwelling and coiled onto adjacent Power Pole

A Downer Construction Partner accessed an Energex Pole and when testing of the strand wire was carried out it was found to be live. When fault finding was conducted an Energex (LV) cable was found coiled on a Pole further down the line which still had the fuse attached.

Local Power authority Energex were called to site to remove the fuse and make the site safe.

- Immediate notification to Downer and Energex was carried out ensuring that the hazard was removed in the quickest and safest possible time.
- **Ensure** when working on any part of the Network, that a complete visual check of the pole is carried out for any obvious visual hazards

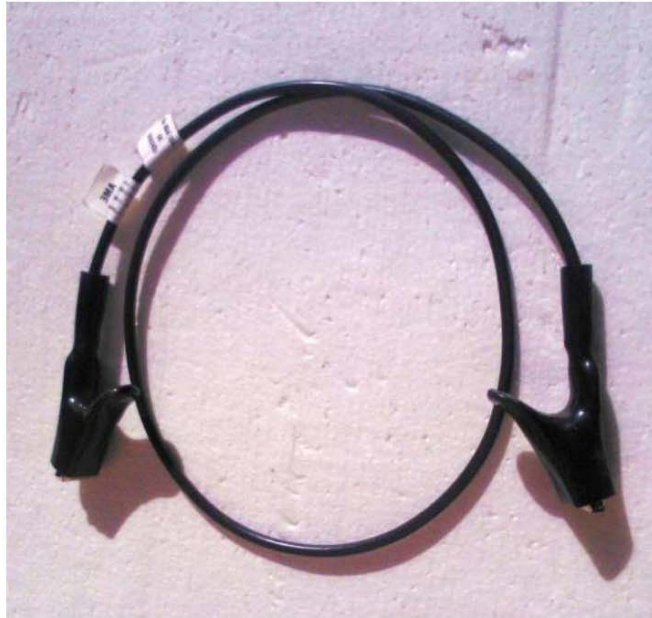
Figure 3

- The equipotential bond, as shown in **Figure 3**, consists of a length of copper conductor (typically 1m) fitted with clamps. The bonds used by Telstra staff will have black insulation on the clamps. The bonds used by Optus Vision will have red insulation on the clamps.

- The equipotential bond is to be installed between the travelling ground and the adjacent strand. The travelling ground must also be connected to earth (Telstra) or power neutral (Optus Vision). A second travelling ground may be used to accommodate both connections, i.e. one travelling ground connected to earth (Telstra) or power neutral (Optus Vision) and a second travelling ground connected to the adjacent strand using the equipotential bond. Electrically insulated gloves must be worn when installing and disconnecting the equipotential bond.

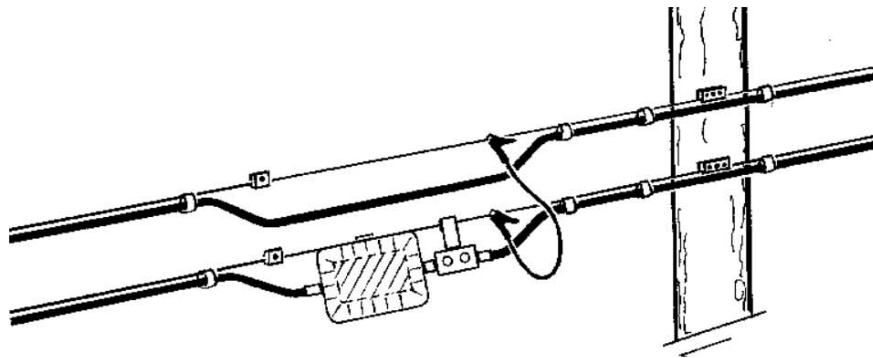
Figure 4

- The equipotential bond is to be placed on the strand above cable loops, adjacent to equipment housings, or expansion loops, so that cable damage is avoided **Figure 4**. Electrically insulated gloves must be worn when installing and removing the equipotential bond.

- Place both clamps on the lower strand or Travelling Ground
- Grasp one clamp firmly in one hand and with a positive action clamp it to the upper strand.
