Safety Alert

ARTC No. 126
Issued 31/08/2020

Loose Wheel Nuts and ARTC Vehicles

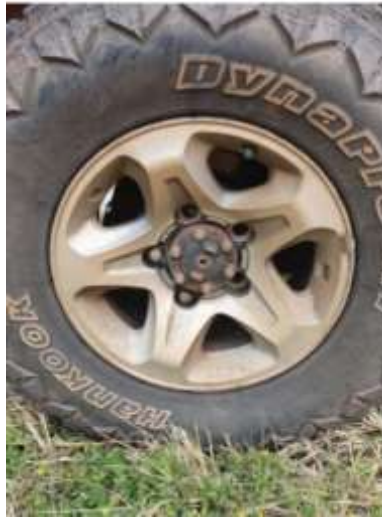
Rims (Non-Compliant) - **X**

This alert has been issued to raise awareness of an incident where a team member was travelling along the Kamilaroi Highway in a Toyota Landcruiser 70 series wagon when during the journey, the driver noticed in the passenger mirror the rear left-hand wheel was vibrating. The driver immediately stopped in a safe location and inspected the wheel which identified 3 missing wheel nuts and 2 broken wheel studs.

Initial investigation found the rims used were alloy as shown below. These are non-compliant with ARTC's rim requirements due to previous experiences with structural fatigue issues

Confirm Landcruiser's, RRV or non-RRV are fitted with the required Heavy Duty Mine Spec Kings Rims as shown below. Further information can be found via the below link, http://www.kingwheels.com.au/index.php?route=product/product&path=65&product_id=408

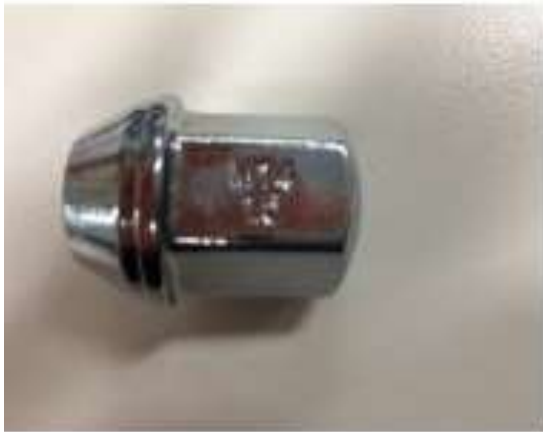
Compliant Nut (40mm)

- All drivers to ensure that the correct wheel nut is used – the wheel nut below is to be used with King Rims

Arrange for wheel nuts to be checked with a tyre brace to ensure they're not loose
