Locomotive sandbox fixing arrangements

The incident

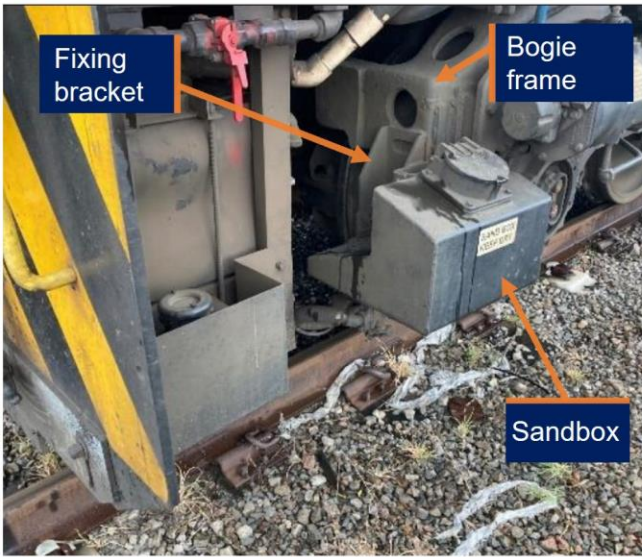
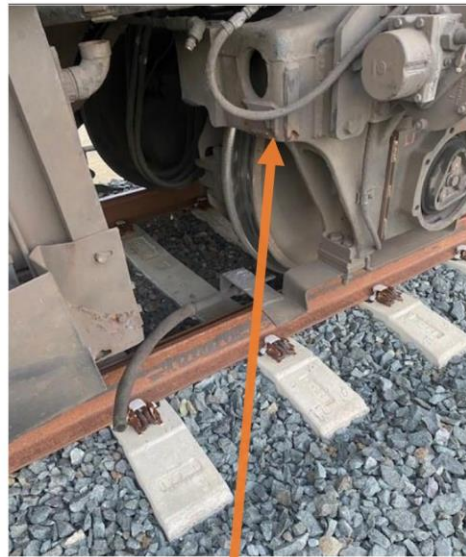
An investigation by the locomotive operator revealed the sandbox was extensively damaged and its fixing points on the bogie showed evidence of failure at the weld attachment points with the bogie frame. Figure 1 (next page) identifies the sandbox type involved in the incident and the actual fixing arrangement failure points.

Bracket failure points

The root cause of the sandbox's displacement could not be categorically determined due to the damage it sustained. However, a subsequent inspection of the locomotive class and the sandbox fixing arrangements revealed a number of fractured welds, fractured brackets and loose bolts. Based on that observation the operator has undertaken several remedial safety actions including:

- Issuing safety advice to its train crew and maintenance staff to be vigilant in inspecting sandbox fixing arrangement condition (checking for fractured welds, fractured brackets and loose bolts) during sandbox provisioning and maintenance inspections.
- Redesigning sandbox fixing arrangements to replace the current bolt arrangement. The redesign involved a change from a welded nut to a bolt and free nut, nyloc nut and nord washer configuration, noting that this type of fixing arrangement has proven successful on other locomotive and passenger cars.
