# **Safety Alert**

### ARTC No. 127 Issued 23/10/2020

## Storage of Forklift Pallet Racking – ARTC safety alert

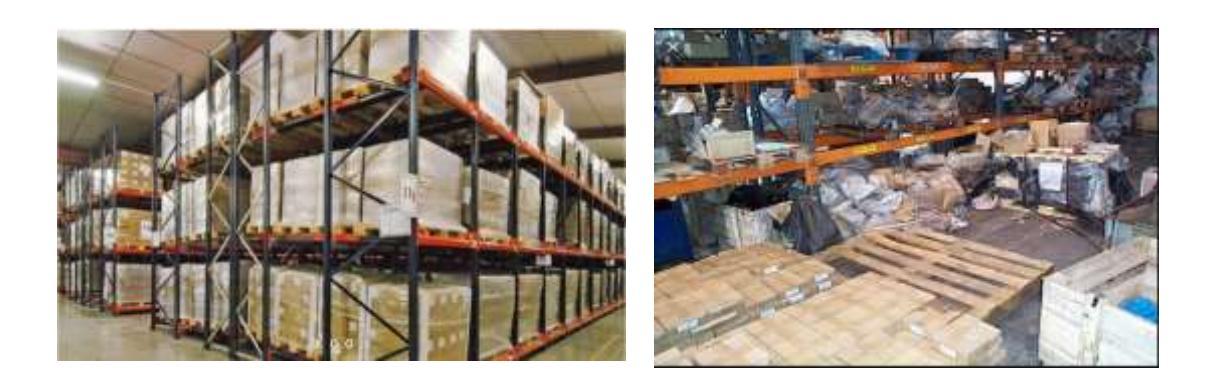
As part of a lifting operation, a forklift was used to remove a pallet that was being stored on the top level of the pallet racking in a warehouse. During the lift, the contents of the pallet moved and the contents has fallen to the ground. Investigation is underway to identify the cause and contributing factors of the incident.

- Has a risk assessment been conducted, hazards identified, and risk controls implemented?
- Has the integrity of the base plates been considered e.g. replacing wooden pallets for stronger products?
- Have exclusion zones been considered to protect others in the work area?
- Has an inspection and maintenance schedule for racking been established?
- Is the Safe Working Load (SWL) rating displayed and visible?
- Has the load on each pallet been secured to prevent movement?
- Where possible have heavier items been stored closer to the ground.
