SAFETY & ENVIRONMENT FLASH

ARTC No. F0023

Inland Rail: N2NS SP1 - Trailer Rollover

Type: Serious near miss

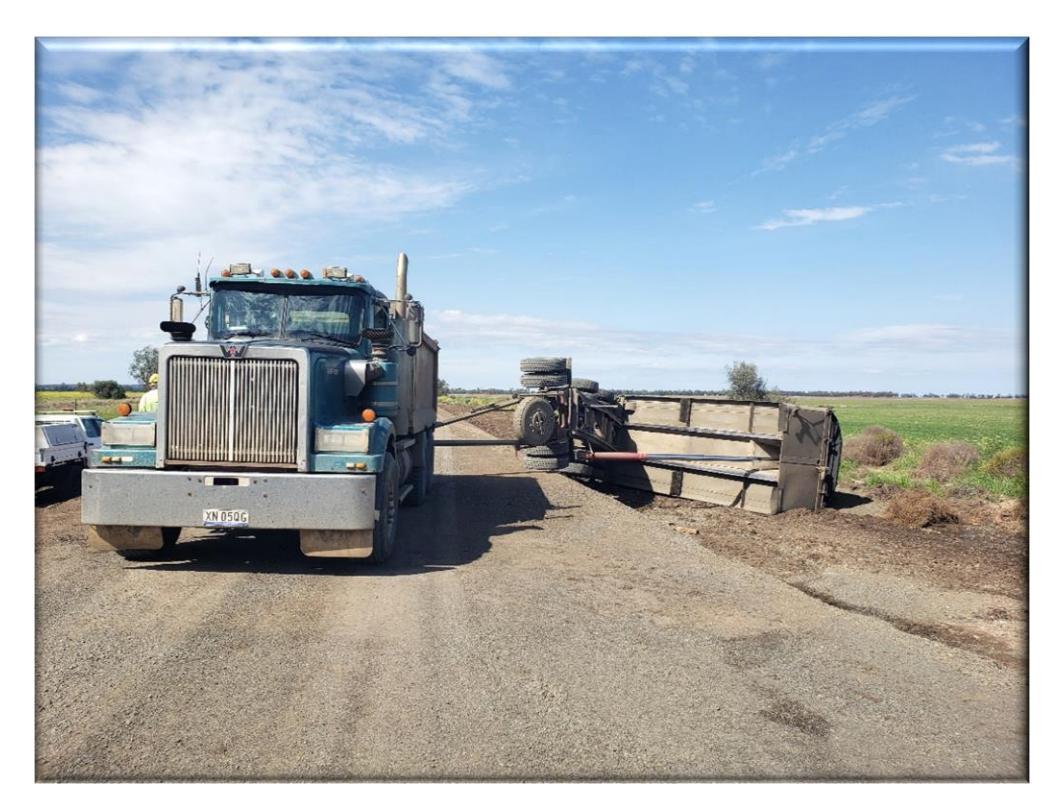
As the truck continued forward, the trailer hoist, still engaged, raised the still loaded trailer. Gravel commenced pouring over the top of the tailgate and the trailer has tipped, falling off the formation and landing on its side. The sudden jolting of the truck and the crash of the trailer as it hit the ground alerted the driver to the incident.

Trailer rollover scene

- This incident serves as a reminder for everyone to be aware of the <u>ARTC Fatal and Severe Risk #5</u> <u>Struck by Mobile Plant</u> and the lifesaving behaviour, I will always stay clear of mobile plant exclusion zones unless I have been authorised to enter.
- 2. Share this HSE Flash Alert with your team to ensure that the contents are discussed/explained to your staff.
- 3. If working with Contractors, ensure they are made aware of this HSE Flash Alert.
- 4. Ensure a method of sign-off is obtained (e.g. via toolbox/safety meetings/morning pre-start/briefings, etc;) to verify that the HSE Flash Alert has been distributed and discussed.
- 5. If you have any safety concerns with this HSE Flash Alert, please speak directly to your supervisor.
