DETAILS OF INCIDENT	
Date:	05/04/2017
Time:	0015hours
Location:	Baan Baa (Job N56)
Rating:	<input checked="" type="checkbox"/> Moderate <input type="checkbox"/> Serious
Classification: (e.g. WHS, RCI, etc.)	<input checked="" type="checkbox"/> WHS <input type="checkbox"/> RCI <input type="checkbox"/> Other _____ If RCI, what is the TCR: _____/20____
Is the incident reportable to Comcare:	<input checked="" type="checkbox"/> No <input type="checkbox"/> Yes, If yes, when was it reported Click here to enter a date.

DESCRIPTION OF INCIDENT (who, what, how, when)

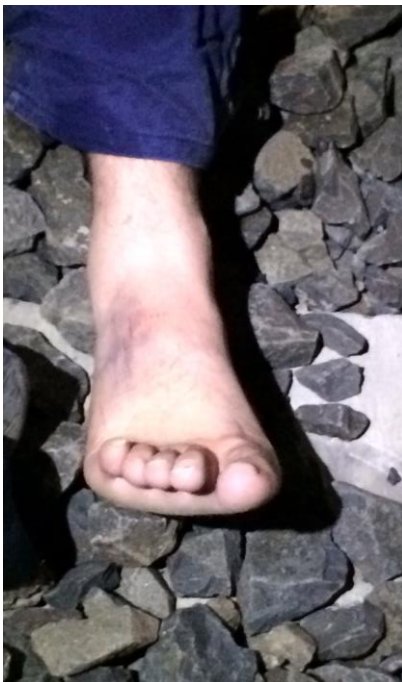
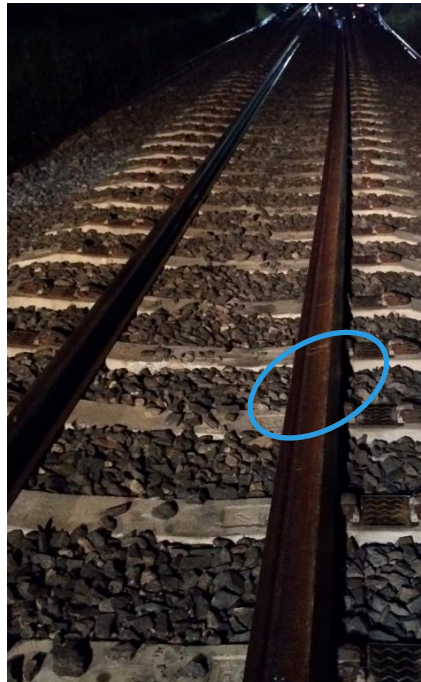
While positioning rail during re-railing activities, a worker sustained an injury to his right foot when a length of rail rolled. The worker did not expect this movement.

The injured worker was controlling and maintaining communications with a front end loader (FEL) assigned to positioning rail for flashbutt welding works. The worker gave the authorisation to the FEL to commence movement of one length of rail. The worker then became momentarily distracted by a co-worker query. While responding to this query, the worker neglected the FEL movement and it continued. In this process the tyre of the FEL has tracked over a second leg of rail which has rolled onto the workers foot right foot. This movement was unexpected by all workers at that location. It struck the worker above the steel cap but below the ankle. Second photo above shows the rail rolled onto its side.

Co-workers nearby, immediately controlled the FEL movement and rendered assistance to the injured worker. First aid treatment was applied onsite (RICE principles), and after a period of time the worker was taken to a nearby medical facility where an anti-inflammatory injection (Ketorolac) was administered.

Subsequent X-rays and medical assessment declared the worker fit to return to work.	
DETAILS OF INJURY/ILLNESS/IMPACT/DAMAGE (include photographs and, if possible, an estimate for when the track can be released)	
The worker returned to work the following shift following medical clearance. The worker sustained minor bruising to right foot.	
IMMEDIATE ACTIONS/CONTROLS TAKEN FOLLOWING INCIDENT TO PREVENT A REPEAT INCIDENT UNTIL INVESTIGATION IS COMPLETE	
All works stopped and the incident was discussed with all site personnel. The discussions reinforced communication protocols and a detailed review of activity and process tasks. One Team principles were reiterated and the discussion stressed need for all personnel to remain focused on allocated tasks.	
AUTHORISED BY	
Name	Anne Modderno
Position	Manager Corridor Works
Shared Learnings	<p><i>It is important for workers to be able to identify when they are becoming distracted from their assigned tasks within the worksite and to take action to remove the distraction accordingly. In this case the worker could have temporarily stopped the FEL movement whilst addressing the separate query, or alternatively asked their co-worker to wait until the FEL movement was complete.</i></p> <p><i>All workers on site should understand not only their specific role and assigned tasks but also the assigned tasks of the remaining crew, and their function on site to facilitate safe delivery.</i></p>
