Safety Alert – March 2019

Rail Safety Incidents during a Local Possession Authority (LPA)

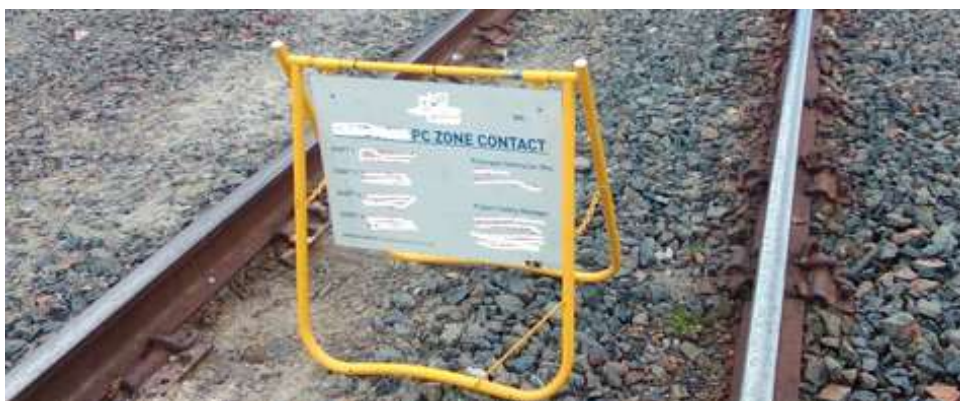
TfNSW would like to share an example of good practice where a PC contact detail board has been positioned at the worksite limits to provide an additional level of warning to drivers when approaching the boundary. They position a Sandwich Board at the worksite side of the yellow light delineation that:

- shows the PC and PO contact details (mobile phone) and Km of the worksite limits;
- is High Visible (in line with Sydney Trains Standards i.e. not Red or Green);
- is at least 1 metre high, is easily removed, and can be secured in high winds.
